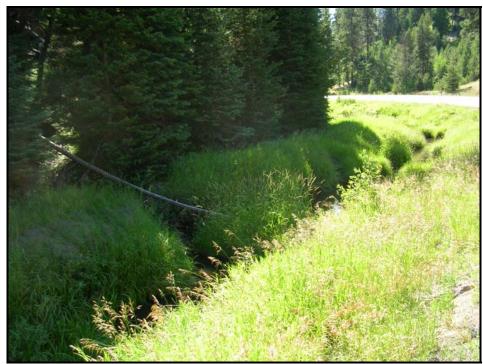
Figure 73. Round Valley Creek.

Riparian-wetland species include beaked sedge (*carex rostrata*), nebraska sedge (*carex nebrascensis*), baltic rush (*juncus balticus*), horsetail (*equisetum arvense*), watercress (*rorippa nasturtium-aquaticum*), red-osier dogwood (*cornus sericea*), brook grass (*catabrosa aquatica*), hardstem bulrush (*scirpus acutus*), fowl manna grass (*glyceria striata*), drummond willow (*salix drummondiana*), yellow willow (*salix lutia*), and geyers willow (*salix geyeriana*). In general, riparian zones were dominated by sedge/grass communities and to a lesser extent by willow/sedge communities.

Channel erosion was not excessive in Round Valley Creek downstream of where it enters the Highway 55 canyon. However, excessive erosion was found in sections in the meadow area upstream. Banks were less than 80% stable.

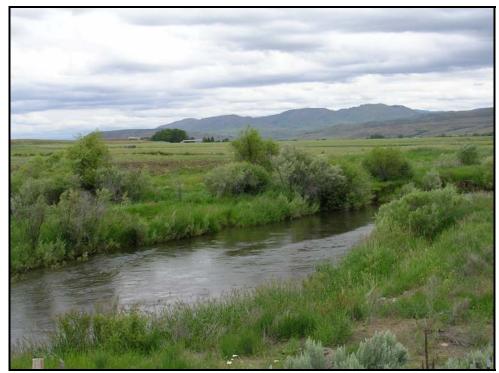
Figure 77. Squaw Creek at Mouth.

The Squaw Creek watershed drains approximately 218,900 acres with an estimated average runoff of 110,000 acre-feet/year, making it one of the largest tributaries to the Payette River (Figures 77 and 78). The headwaters of Squaw Creek originate in forested land at over 7,000 feet and it enters Black Canyon Reservoir at just over 2,500 feet. There are two wide valley types within the lower Squaw Creek drainage: Ola Valley and Sweet Valley. The lower 20 miles of Squaw Creek runs through about 7,000 acres that is under some form of surface irrigation. 180-acre Sage Hen reservoir is located in this watershed and is a popular fishery. Land use is predominantly rangeland with irrigated agriculture concentrated in the lower reaches. Agriculture represents over 50% of the economy in this watershed. The majority of irrigation is flood irrigation. Livestock use is primarily cattle.
